A procedure to track vibration modes under changing external factors: application to a pedestrian bridge

Soria, José M. ; Díaz, Iván M. ; García-Palacios, Jaime H. ; Ibán, Norberto ; Lorenzana, Antolín

ABSTRACT

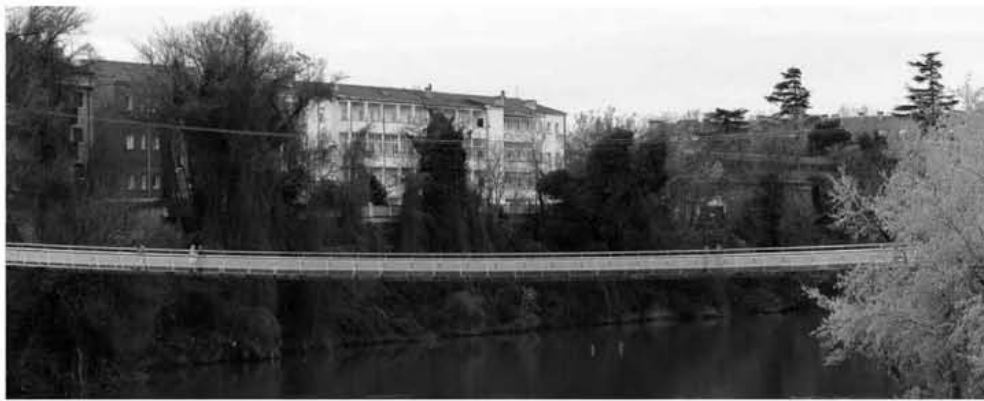
Figure 1. *Pedro Gómez Bosque footbridge. Landscape view.*

PGB footbridge, sited in Valladolid (Spain), is a slender and lightweight structure that creates a pedestrian link over the Pisuerga River between a sport complex and the city centre (see Figure 1). This bridge, built in 2011, is a singular stress-ribbon footbridge born by a pretensioned catenary-shape steel band with a single span of 85 m that provides minimal impact on the surroundings. The structure mainly consists of a Corten steel band of 94 m long, 3.6 m wide and only 30 mm thick which is pre-tensioned and anchored to the two abutments. The complete steel band is fabricated by welding 8-meter long sheets and a number of 110 precast concrete slabs lay on the steel band [17]. These slabs do not have bearing capacity in such a way that the only structural element is the band. The structure is completed by rubber flooring and a stainless steel glass handrail.

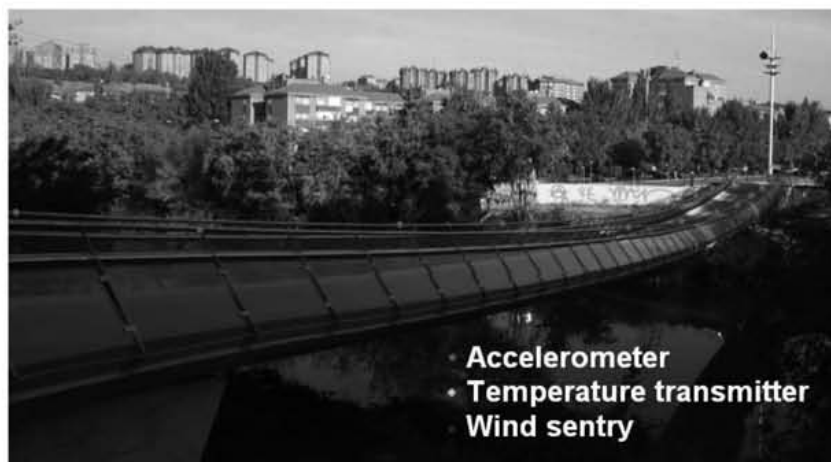
Figure 2. *Monitoring system. Distribution of sensors.*

capacitors, one to each channel, were placed to fix the frequency bandwidth to 100 Hz. Second, since the accelerometer has to be supplied by 3.6 V to get its maximum nominal sensitivity of 500 mV/g, the power supply unit of 12 V and a voltage regulator to 3.6 V were integrated into each circuit board in order to avoid power losses by the long distance wires. Thirdly, an operational amplifier was used to reduce significantly the output impedance, achieving thus a good signal-to-noise ratio for acceleration parameter (constant sensitivity and low noise). The achieved signal-to-noise ratio was $25 \mu\text{g}/\sqrt{\text{Hz}}$, which was considered to be enough for monitoring the structural vibrations. Finally, each circuit board with all its components was covered with a plastic coating to protect it from environmental conditions. Then, the accelerometers were ready to be installed inside the tube of the handrail. The sensing system was completed by a temperature sensor (model T0110 transmitter of Comet) and a wind sentry (model 03002L of R.M. Young Company) to measure the speed and direction of the wind. The temperature sensor and wind sentry were installed on the public light tower sited closed to the structure (see Figure 2).

The monitoring system then comprises 57 voltage channels that are processed continuously. The data logger CompactRIO 9076 (National Instruments) with two NI 9205 with 32 analog input channels is used for real-time data acquisition. The frequency sampling for each channel was chosen to be 200 Hz, enough to identify the modal parameters of the structure and to avoid aliasing problems during the post-processing. The actual orientation of the accelerometers installed inside the handrail is unknown. However, the Euler angles between the accelerometer coordinate system and the structure coordinate system can be derived taking into account the following: (i) the longitudinal axis of each accelerometer matches with the longitudinal axis of the footbridge, and (ii) the accelerometers are able to measure acceleration due to gravity. Therefore, the transformation matrix between both coordinate systems is obtained, and then, the acceleration in the global axes can be finally calculated [18]. Before its final installation, a laboratory validation was carried out and after the installation, an in-situ validation was performed by comparing against conventional piezoelectric accelerometers.
